Ductile-to-brittle transition temperature (DBTT) in steels and its significance in design and manufacturing

By: Kamran Khodaparasti

Tehran, June 2009

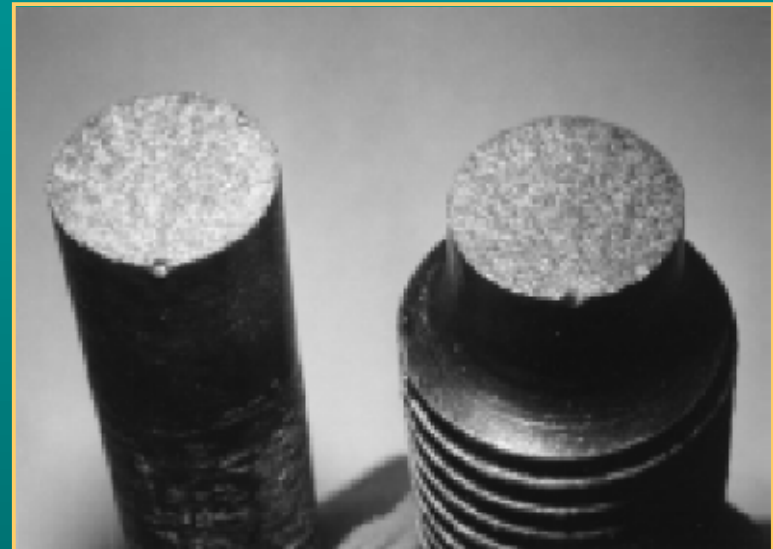
Ductile fracture
(cup-and-cone)

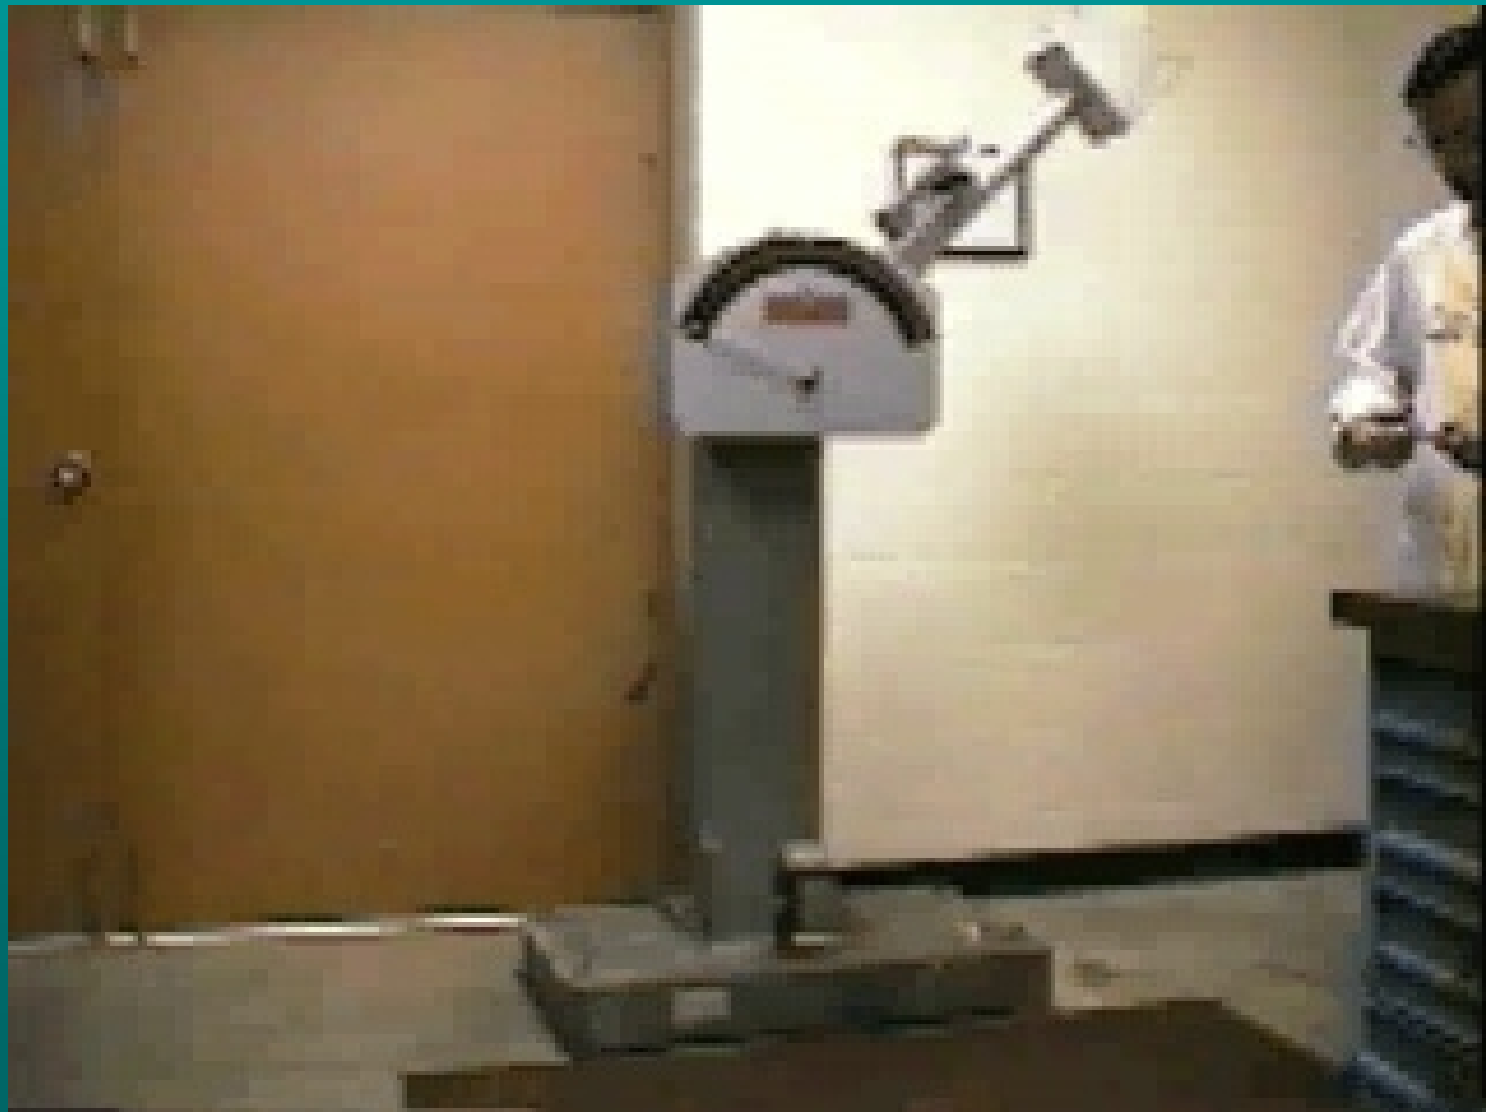
Impact test machine

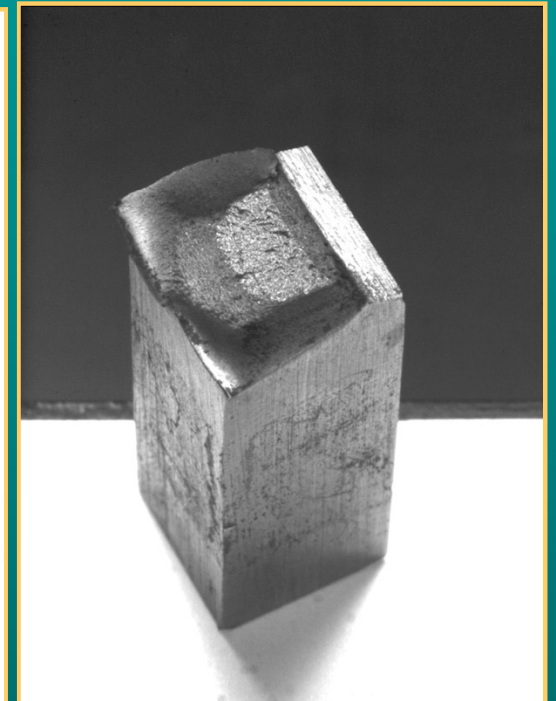
Fracture surface

fracture surfaces of A36 steel Charpy V-notch specimens tested at indicated temperatures (in °C).

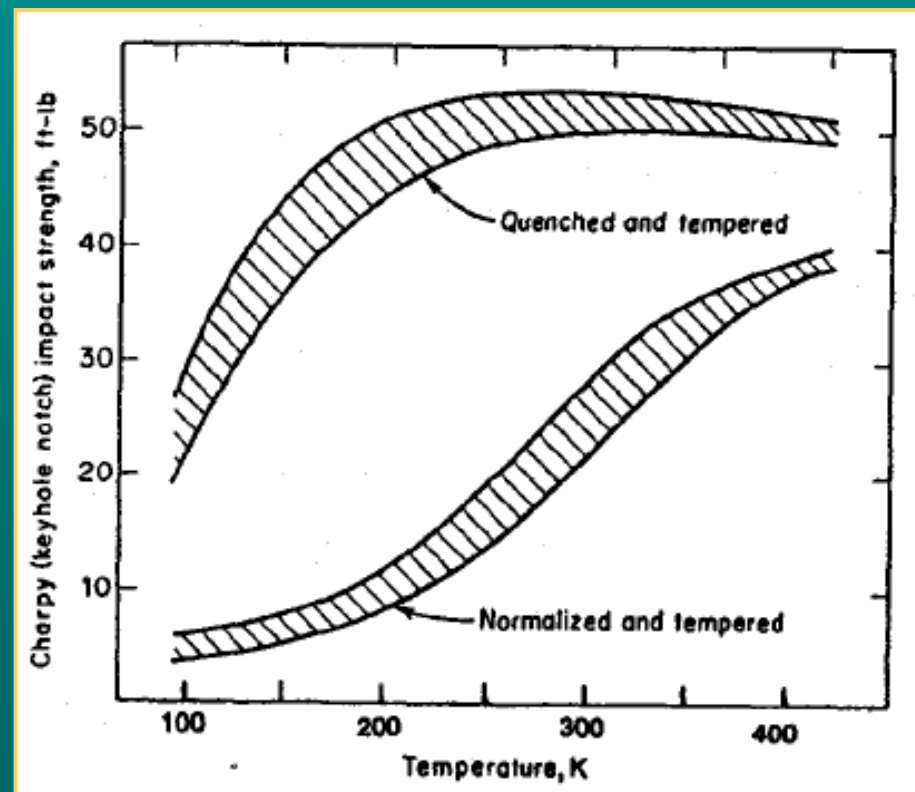
Both heat treatments produce the same hardness but widely different DBTT

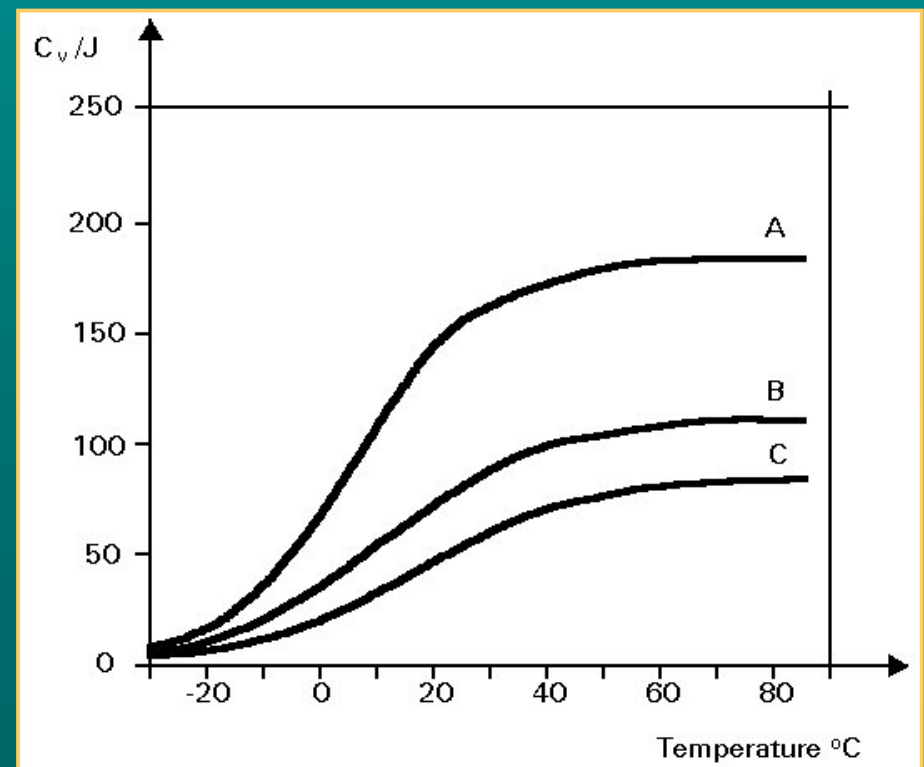
- n The notched-impact properties of rolled or forged products vary with orientation in the plate or bar.

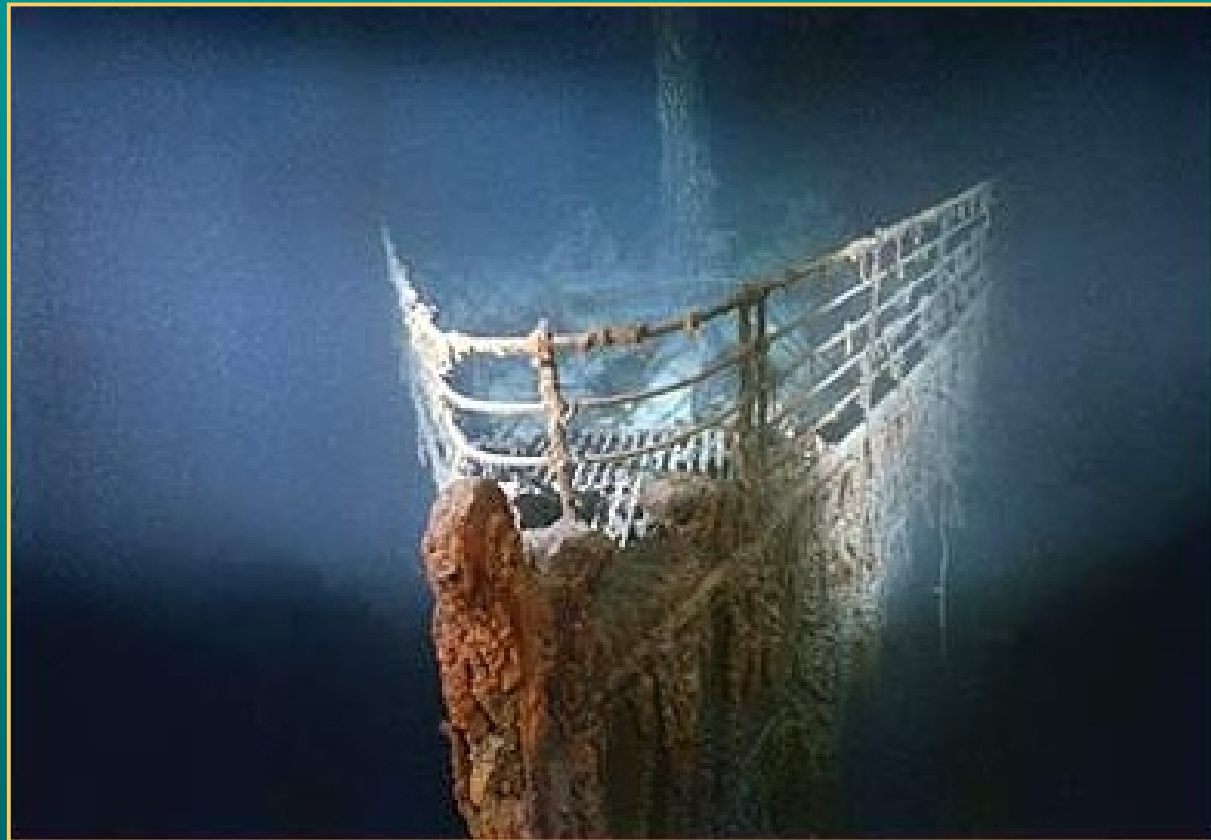
The bow of the Titanic as it appeared during 1986 expedition

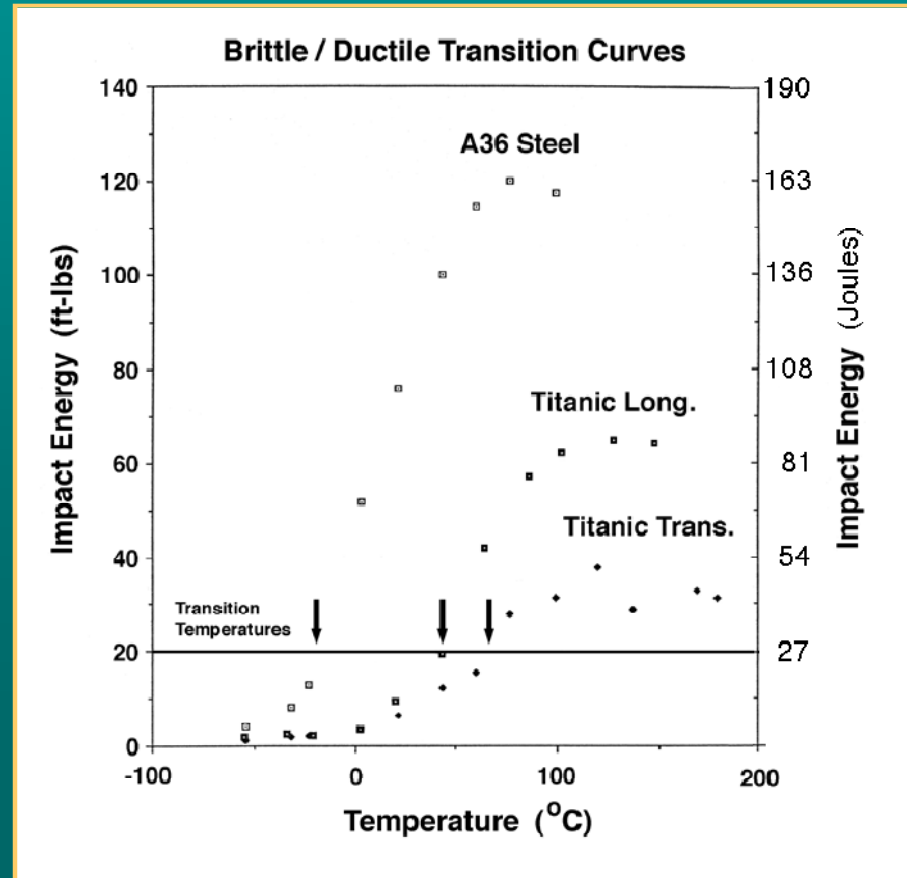
- n The ductile-brittle transition temperature for the longitudinal specimens was 33°C .

- n The steel used to construct the Titanic's hull, though adequate in strength, possessed a high DBTT (at the time of the collision, the sea water temp. was $-2\text{ }^{\circ}\text{C}$)
- n The low toughness was likely due to a complex combination of factors, including low Mn content, a low Mn:C ratio, a large ferrite grain size and large and coarse pearlite colonies.
- n The steel used was probably the best plain carbon ship plate available at the time of the ship's construction.
