# Corrosion Resistance of Materials in the Mars Environment

**This paper presents the results of a literature search of available data relevant to corrosion resistance of materials in the Mars environment, as a background for future experimental work. Corrosion resistance is one of the most important properties in selecting materials for landed spacecraft and structures that will support surface operations for the human exploration of Mars. Currently, the selection of materials is done by assuming that the corrosion behavior of a material on Mars will be the same as that on Earth. This is understandable since there is no data available on the corrosion resistance of materials in the Mars environment. However, given that corrosion is defined as the degradation of a metal that results from its chemical interaction with the environment, it cannot be assumed that corrosion is going to be the same in both environments, since they are significantly different. This theoretical study was motivated by the suggestion, by a team of researchers, that some of the structural degradation observed on Curiosity's wheels may have been caused by corrosive interactions with the transient liquid brine

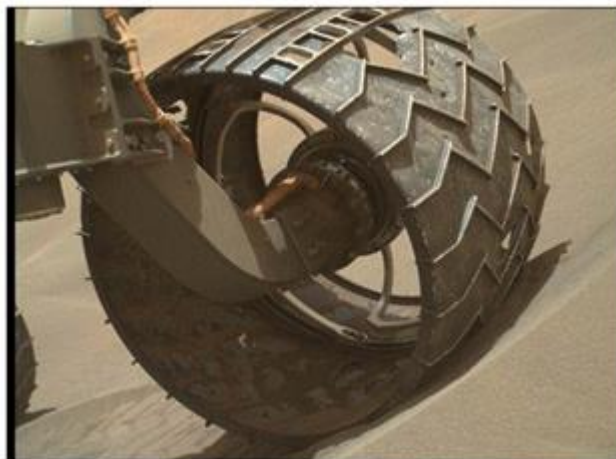
**Figure 2.** Curiosity's wheels showing signs of severe damage after almost 10 km of traverse.

Despite the overwhelming evidence that oxidation of materials is unavoidable on Mars, corrosion of materials has not been a major concern for Mars Missions, due to its arid atmosphere and the lack of evidence of liquid water. The recent discovery of perchlorates is indicative of their widespread presence on the surface of Mars.<sup>12</sup> Perchlorate and chlorate ( $ClO_3^-$ ) species have also been found in a Martian meteorite.<sup>13</sup> Their role in lowering the freezing temperature of water in the Martian soil supports the presence of transient liquid water on Mars.<sup>9</sup> This new found evidence of liquid brines coincided with the surprisingly significant damage observed on Curiosity's wheels (Figure 2 and Figure 3). Soon after its landing, disturbing cracks started to appear on some of them. This was surprising, given that the design was similar to that of the Mars Exploration Rovers (MERs), Spirit and Opportunity, which never showed such a wear and tear when experiencing the same mean pressure (i.e. platform weight over wheel area in contact with a flat terrain). It has been hypothesized that, the daily contact of the wheels with the corrosive perchlorate solutions during every night, may have weakened the scratched surface of the anodized aluminum, making it more susceptible to damage against sharp rocks. Rover engineers concluded that the damage was caused exclusively by mechanical forces. Although the large cracks in the wheel are likely caused by mechanical damage,

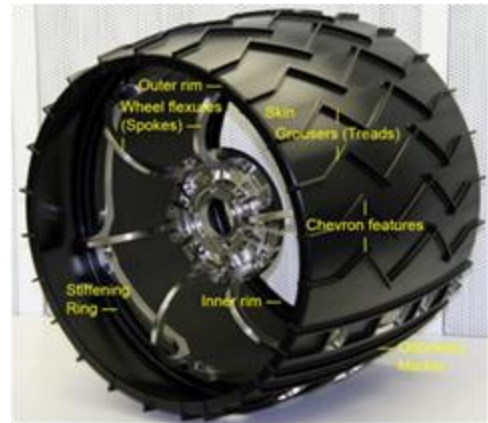
**Figure 1.** Curiosity's wheel made from a single piece of machined aluminum alloy AA7075-T7351. The main rim is 1.9 cm thick (0.75-inches). NASA / JPL / Emily Lakdawalla.

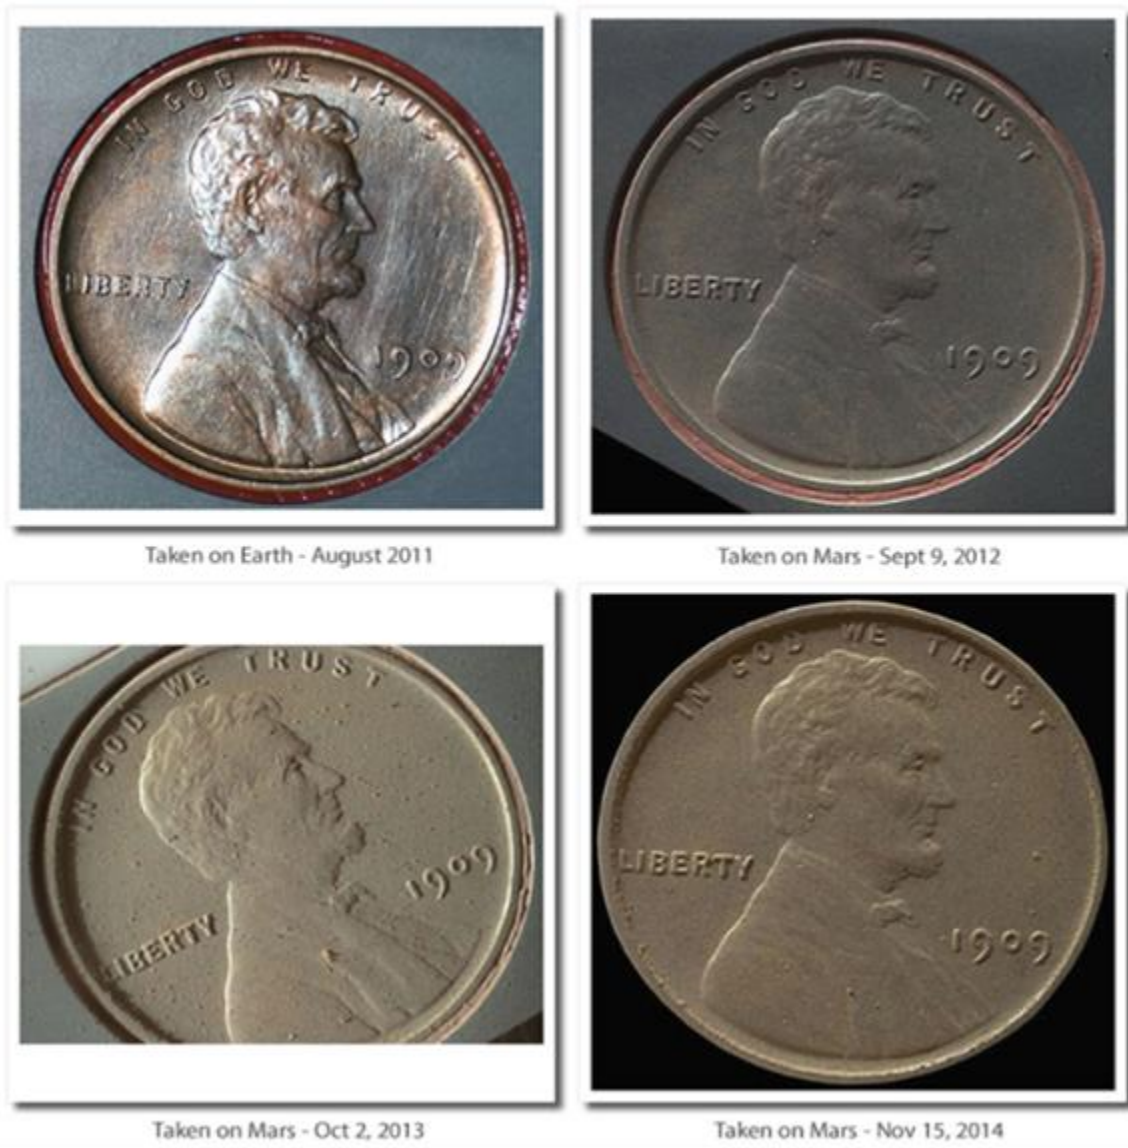
**Figure 6.** Four different photos of the 1909 VDB Lincoln Cent on Mars rover Curiosity. VDB are the initials of Victor David Brenner who designed the coin. The first photo was taken on Earth in August 2011. Subsequent photos were taken on Mars on September 9, 2012, October 2nd, 2013, and on November 15, 2013. Image credit: NASA, JPL-Caltech, MSSS.

Although the current rover on Mars, Curiosity, does not have electrochemical sensors, it has captured images that can provide a visual indication of the interaction between materials and the Mars environment. A relevant example is shown in Figure 4.<sup>30</sup> The photo shows the Lincoln cent that is attached to a calibration target used by the rover's camera known as the Mars Hand Lens Imager, or MAHLI. Figure 5 shows an image of elongated crystal shapes taken on the surface of Mars by the Curiosity rover. An inset on the picture shows the 1909 VDB Lincoln cent.<sup>31</sup> Curiosity was launched on November 26, 2011 to search areas of Mars for past or present conditions favorable for life, and conditions capable of preserving a record of life. The rover landed on the planet on August 6, 2012. It has been surveying a small portion of the planet ever since. This is the first time that a coin has been subjected to the conditions of another planet while being monitored. Figure 6 shows four different photos of the Lincoln cent taken on Earth and on Mars. The only change that can be visually observed on the pictures is the accumulation of Martian dust, which is interesting because the coin is mounted on a vertical position. The Lincoln cent appear to show no visual signs of corrosion of copper.

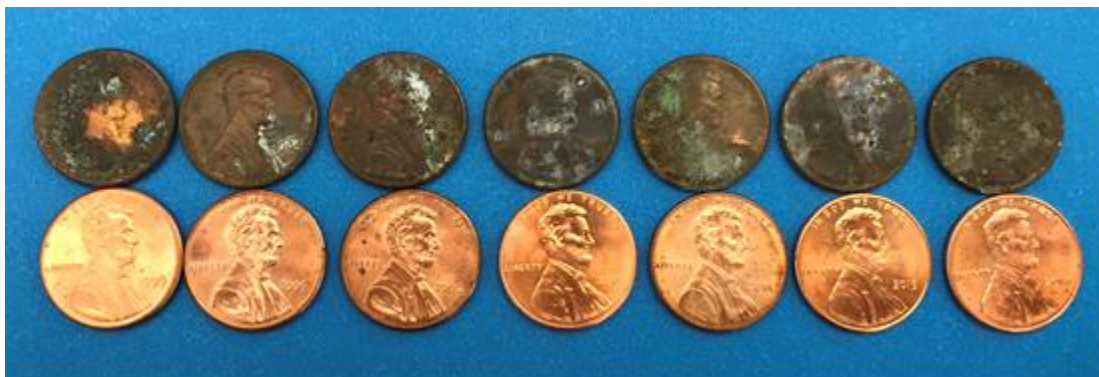
**Figure 7.** U.S. pennies selected at random from a household jar of coins to show different states of corrosion: the pennies at the bottom (left to right) date from 1999, 2005, 2006, 2011, 2014, 2015, and 2017; the pennies at the top are corroded and only the second penny from the left has a visible date (1984).

Figure 7 shows a set of U.S. pennies, selected at random from a household coin jar, to show signs of corrosion. The pennies at the bottom (dated from 1999 to 2017) show very little or no visible signs of corrosion. The pennies at the top are dull and covered by corrosion products. Although the cause of corrosion is unknown, because the pennies were not subjected to a controlled experiment, it can be hypothesized that the pennies at the top were exposed to more corrosive environments than those at the bottom. When copper is exposed to air, its shiny copper color will transition to dull brown. At a later stage, the formation of copper sulfate, carbonate, and chloride salts, in varying concentrations will turn the surface green (as seen on some of the pennies on the top row). This process is influenced by many factors such as: moisture, temperature, and the environment to which the metal has been exposed to. The penny shown on Figure 6 shows no sign of corrosion. This is not surprising given that the penny has been exposed to the Martian atmosphere which contains only minor amounts of water (210 ppm).<sup>32</sup>
